Contract #: 04-0120F4Cty: SF/ALA Rte: 80 PM: 13.2/13.9File #: 69.28**WELDING INSPECTION REPORT****Resident Engineer:** Pursell, Gary**Address:** 333 Burma Road**City:** Oakland, CA 94607**Report No:** WIR-013244**Date Inspected:** 21-Mar-2010**Project Name:** SAS Superstructure**OSM Arrival Time:** 700**Prime Contractor:** American Bridge/Fluor Enterprises, a JV**OSM Departure Time:** 1900**Contractor:** Zhenhua Port Machinery Company, Ltd (ZPMC), Changxing Island **Location:** Shanghai, China**CWI Name:** Zhao Chen Sun**CWI Present:** Yes No**Inspected CWI report:** Yes No N/A**Rod Oven in Use:** Yes No N/A**Electrode to specification:** Yes No N/A**Weld Procedures Followed:** Yes No N/A**Qualified Welders:** Yes No N/A**Verified Joint Fit-up:** Yes No N/A**Approved Drawings:** Yes No N/A**Approved WPS:** Yes No N/A**Delayed / Cancelled:** Yes No N/A**Bridge No:** 34-0006**Component:** Tower Trial Assembly**Summary of Items Observed:**

TOWER TRIAL ASSEMBLY:

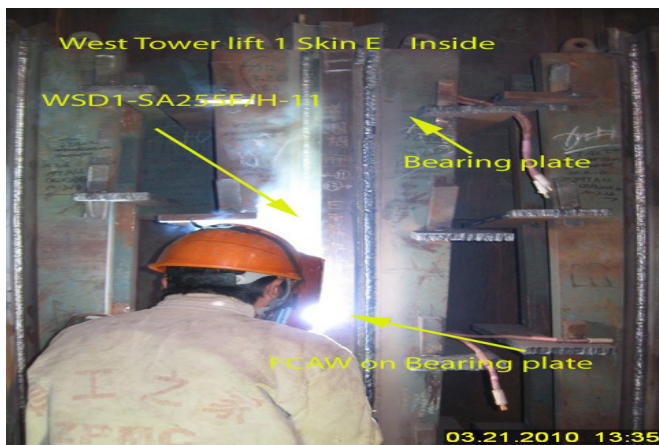
This QA Inspector observed ZPMC qualified welding personnel identified as 205649. Perform Flux Core Arc Welding (FCAW) on West Tower lift 1 skin E inside, bearing plate. Joint identified as WSD1-SA225F/H-11, ZPMC QC Identified as Liu Zhi, The welding parameters as measured using QC's calibrated instrument appeared to be in general compliance with WPS-B-T-2333-Tc-P4-F. For more information see below attached photo.

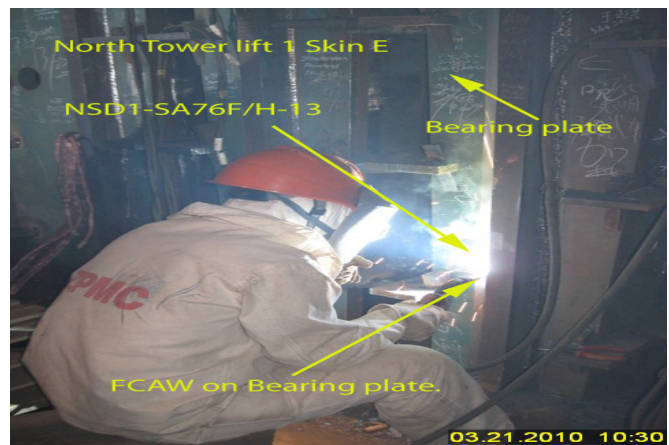
This QA Inspector observed ZPMC qualified welding personnel identified as 066683. Perform Flux Core Arc Welding (FCAW) on North Tower lift 1 skin E inside, bearing plate. Joint identified as NSD1-SA76-F/H-21, 13. ZPMC CWI Identified as Ye Yang Jun, The welding parameters as measured using QC's calibrated instrument appeared to be in general compliance with WPS-B-T-2333-Tc-P4-F. For more information see below attached photo.
